Failure Analysis Guide

Eliminate Potential and
Future Problems

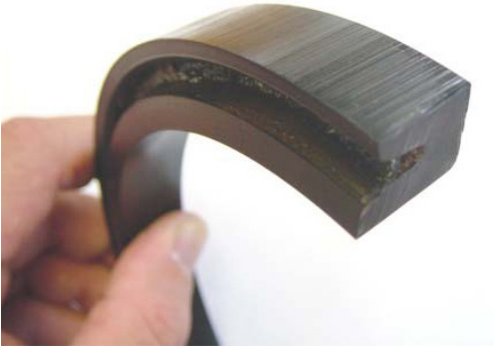
Above: NBR piston u-cup with abrasion marks at the seal lip and migrating across the dynamic surface.

- Surface finish that's too rough
- Damaged sliding surface
- Insufficient lubrication
- Contamination

- Rods that ground with non-oriented finish or roller burnishing
- Barrels honing and roller burnishing

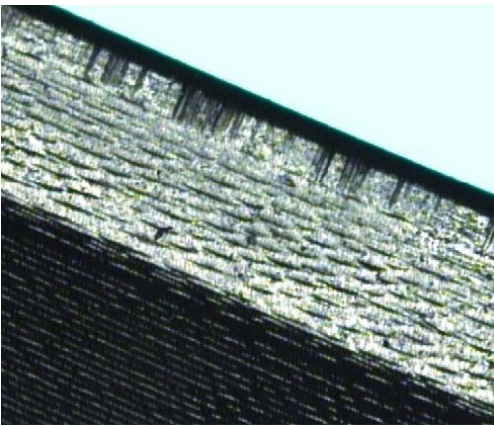
Above: Close up view of a u-cup seal lip showing abrasion marks.

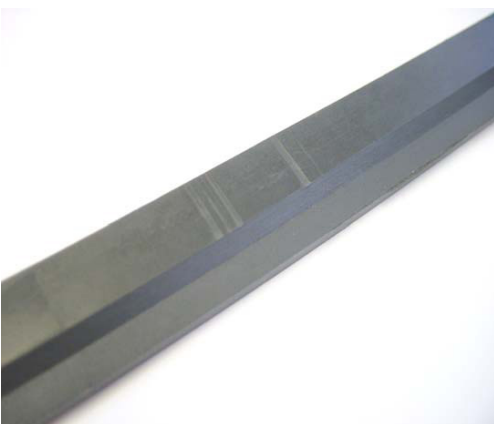
Above: PTFE seal with abrasion marks at the seal lip and migrating across the dynamic surface.

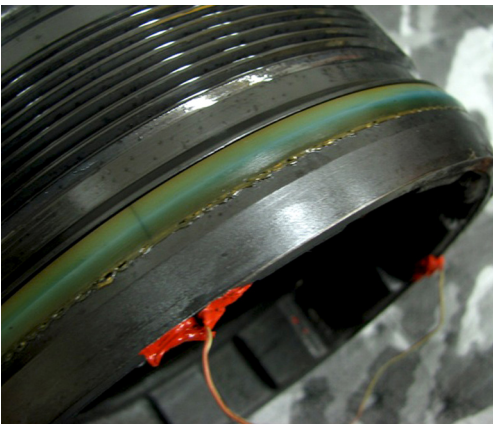
- System pressure too high
- Larger than normal extrusion gap
- Cylinder expansion
- Wrong seal material

Above: Polyurethane static seal showing signs of extrusion.

There is design criteria for extrusion gaps and this criteria is based on the seal material and operating pressures. However, situations arise where the recommendations cannot be met, such as cylinder re-build. To overcome the extrusion potential, seals using back-up rings or the use of reinforced materials are recommended.

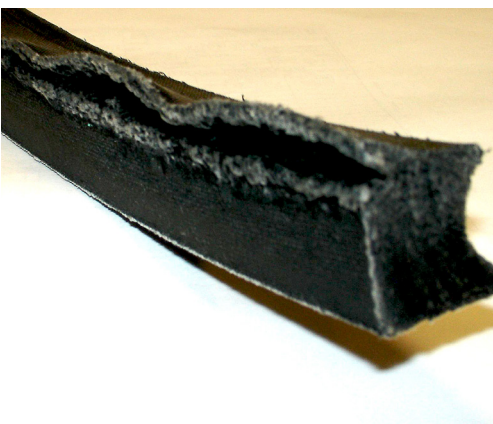
Above: V-packing female adapter ring showing clear signs of extrusion.

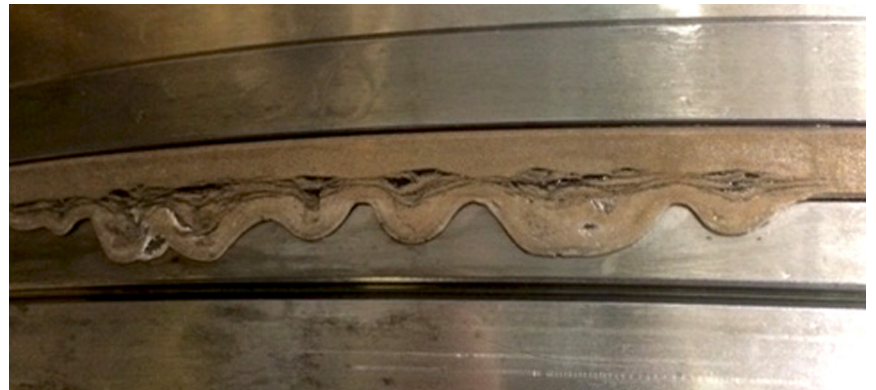
Above: PTFE piston seal showing signs of severe extrusion.

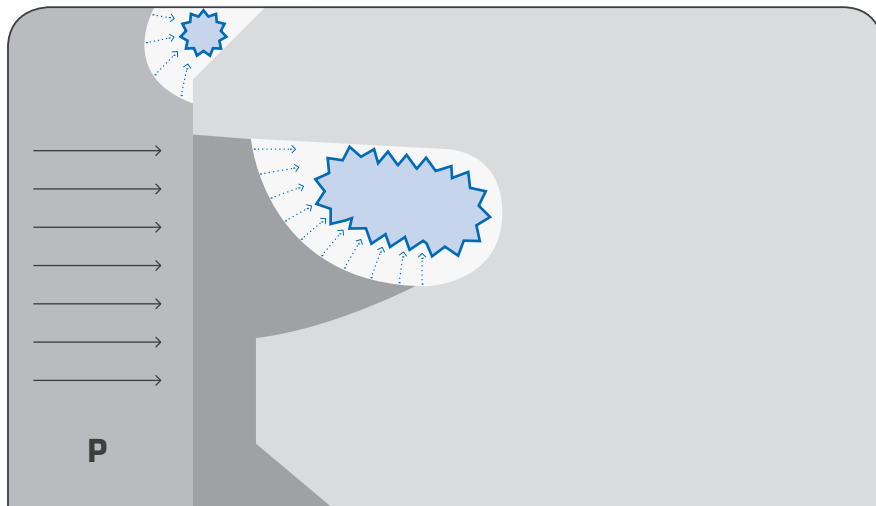
Above: Rapid pressure rise squeezes the air bubbles, causing immense heat which is hot enough to ignite the oil fumes trapped within the bubbles. The result is a burning of the seal face.

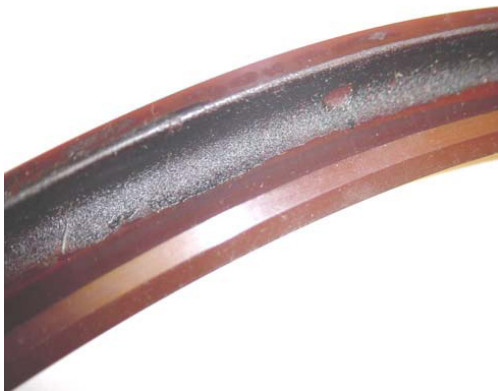
Above: Polyurethane u-cup with dieseling damage.

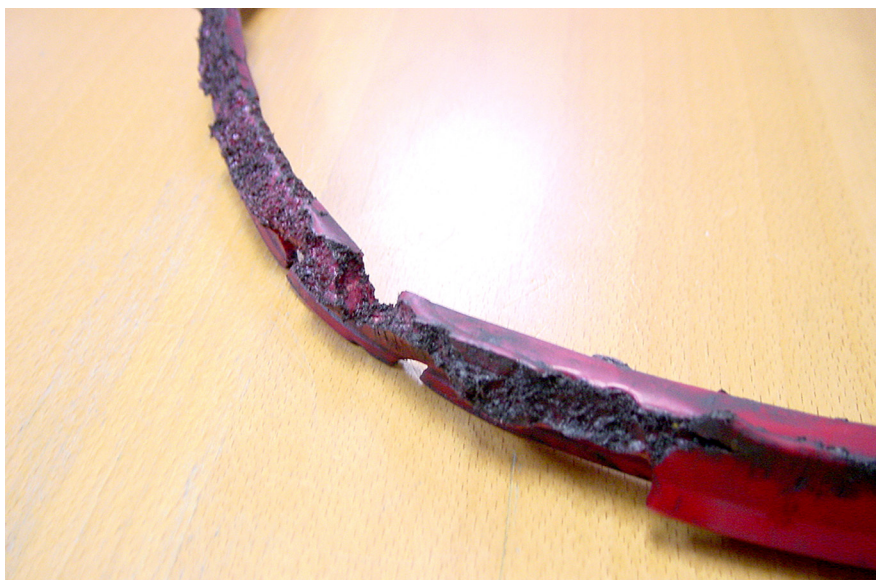
Above: Polyurethane u-cup showing severe dieseling damage.

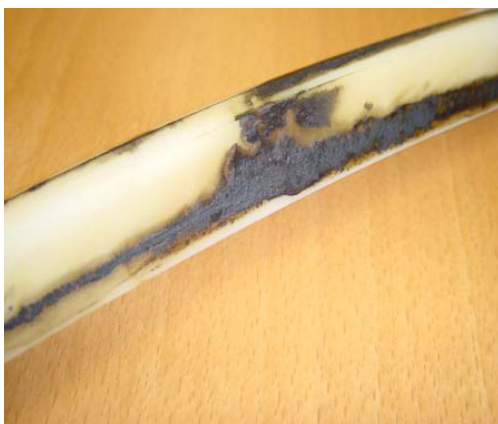
Above: Nylon back-up ring with dieseling damage.

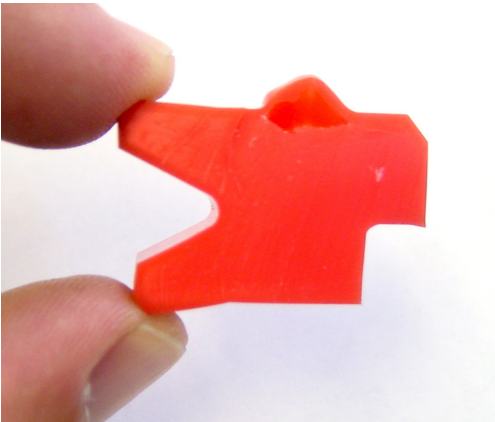
Above: Damaged by explosive decompression.

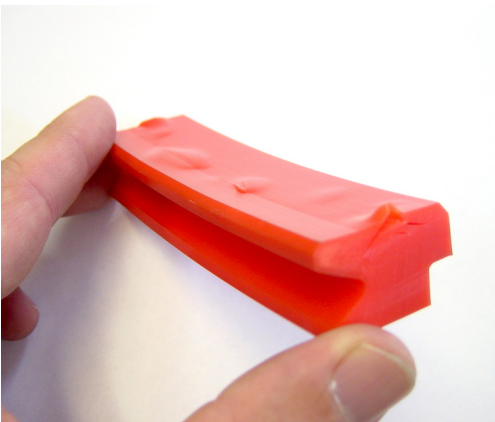
Above: Polyurethane u-cup seal damaged by explosive decompression.

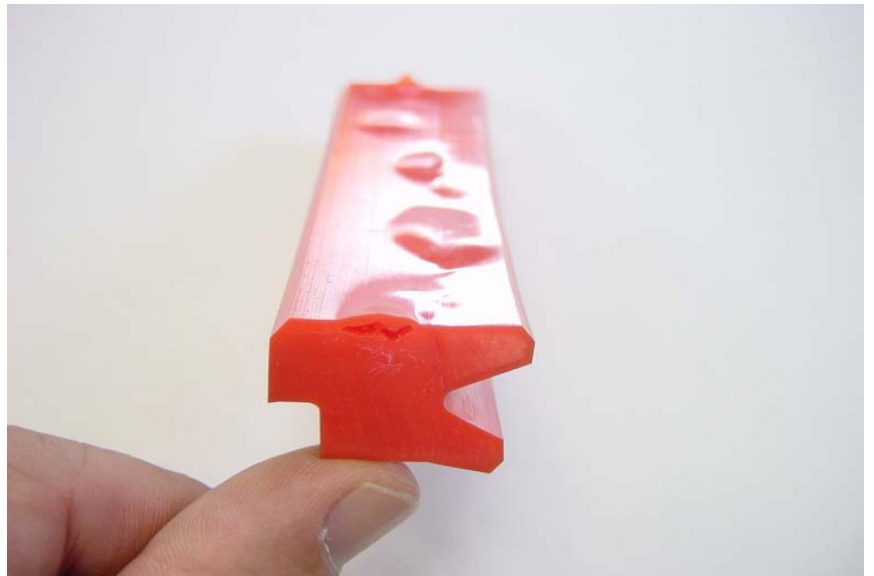
Above: Polyurethane u-cup seal damaged by explosive decompression.

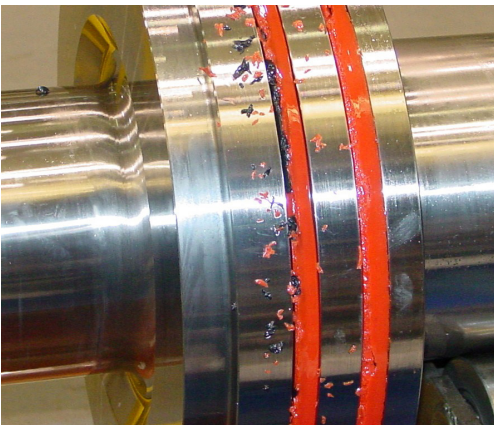
Above: Back-to-back piston u-cup seals showing pressure trapping with reverse extrusion as a result.

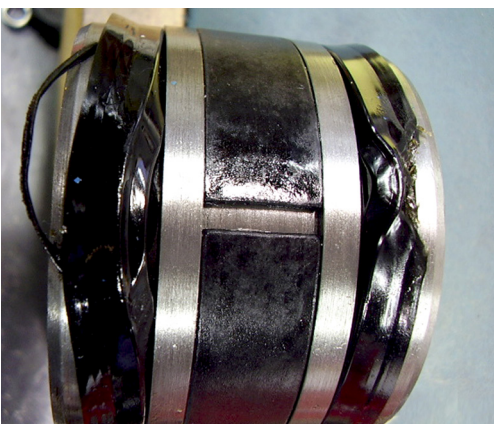
Above: Loaded polyurethane u-cups showing severe pressure trapping and failure.

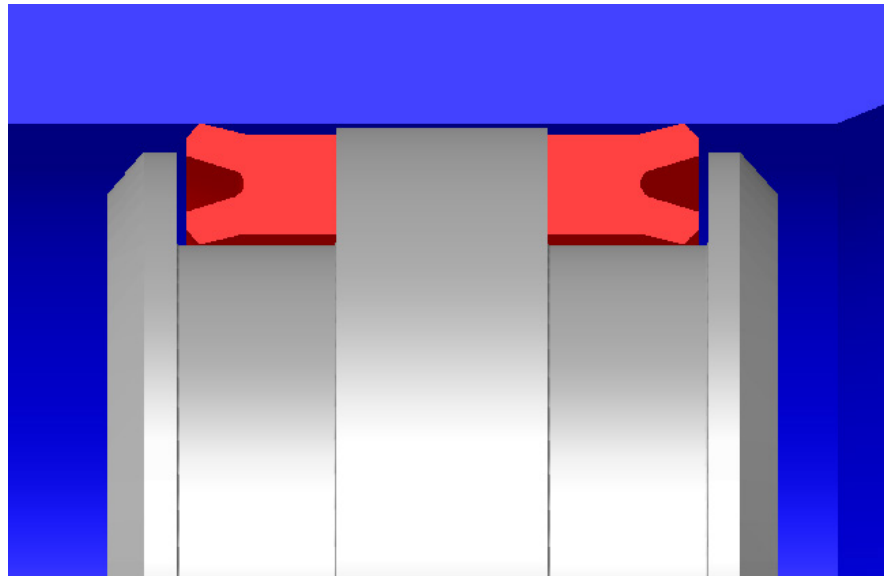
Above: Normal action of piston can cause certain types of piston seals to trap pressure.

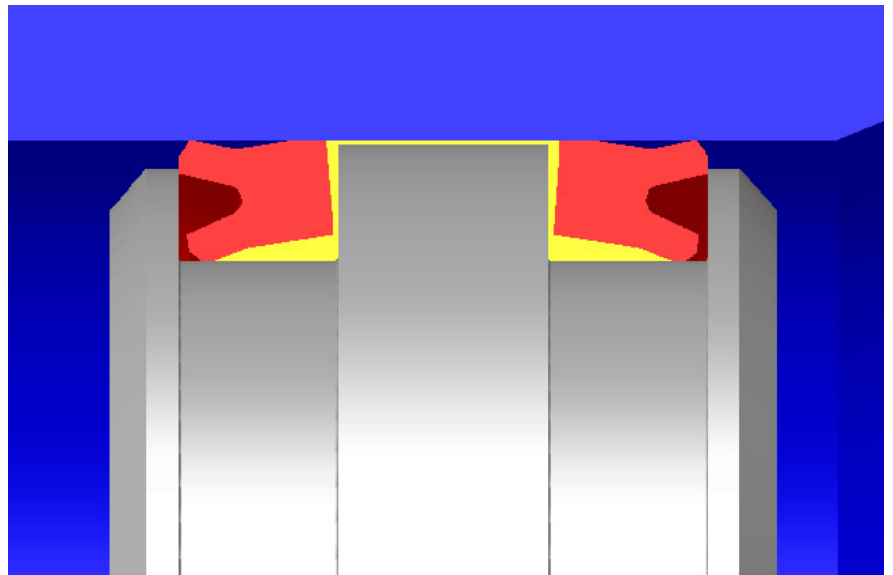
Above: Excessive pressure between the seals can push the seals away from each other, ultimately resulting in pressure trapping failure.

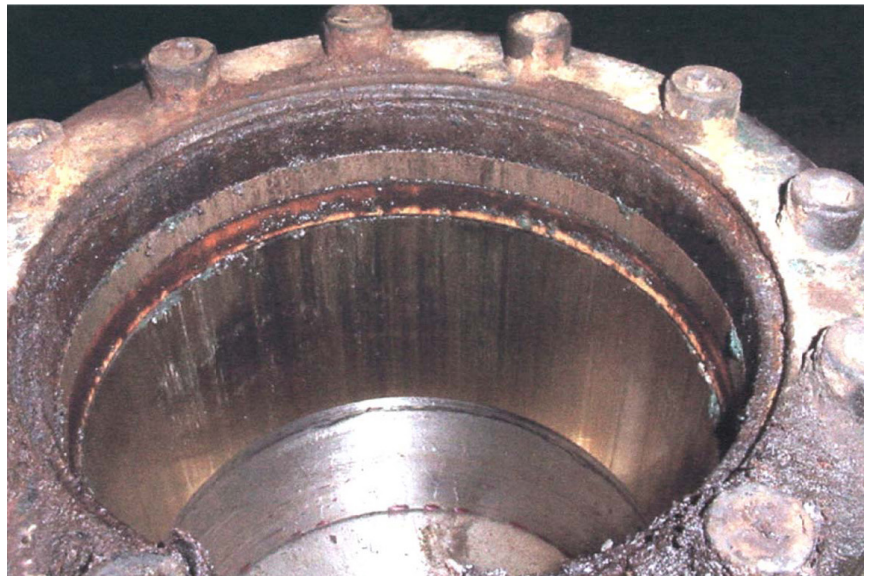
Above: Hydraulic cylinder with severe contamination.

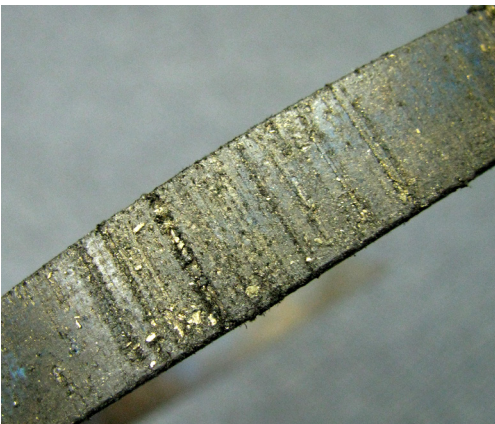
Above: Resin/Fabric guide band damaged by severe metallic contamination.

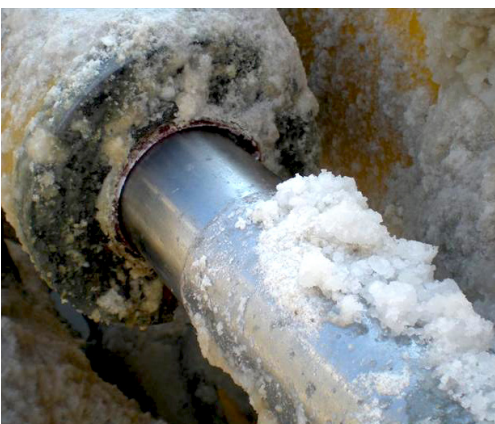
Above: Hydraulic cylinder operating in a severe salt contaminated environment.

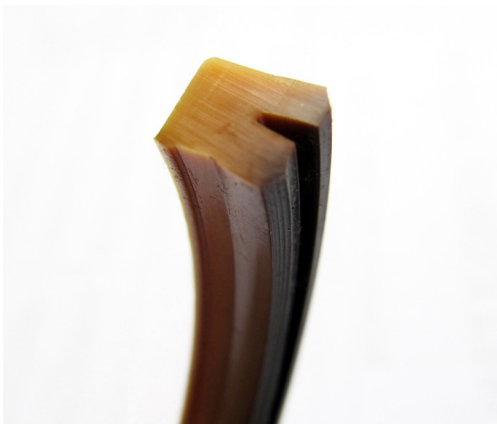
Above: Polyurethane u-cup seal with severe heat damage/cracking.

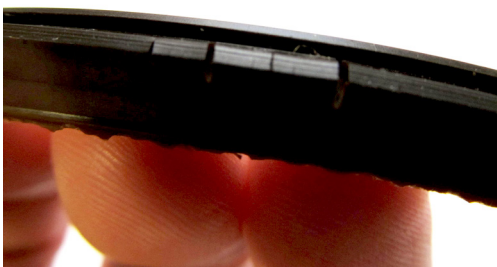
Above: Inner lip of a nitrile rotary shaft seal that has cracked from high running temperatures.

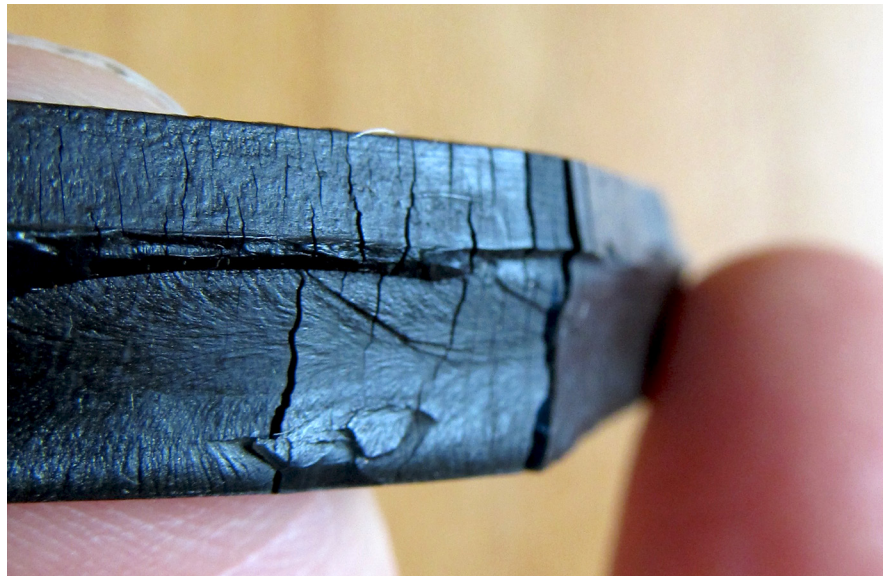
Above: Polyurethane u-cup seal with severe heat damage/cracking.

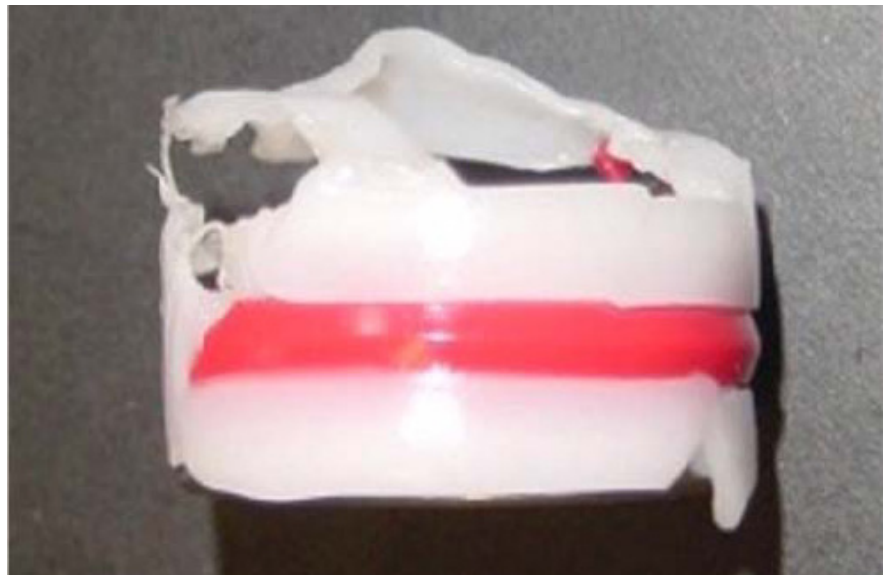
Above: Multi-component piston seal exposed to temperatures that caused the components to melt.

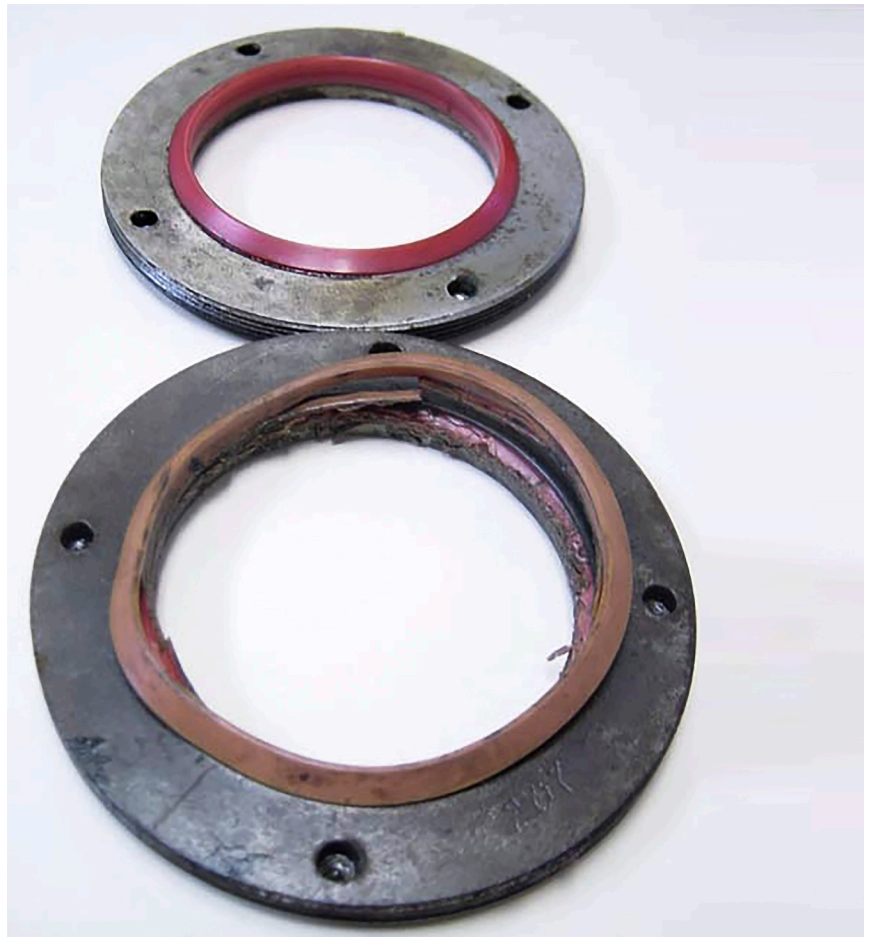
Above: Swelling failure of a dirt wiper. Wiper at top is new for comparison.

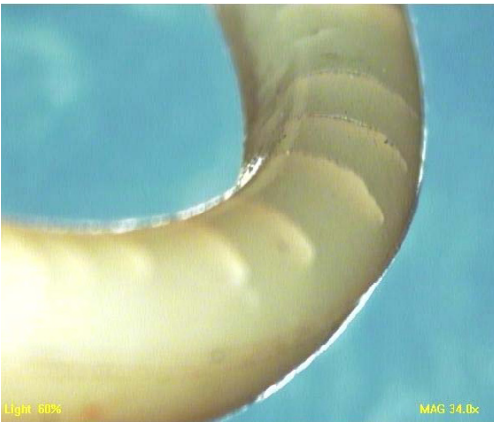
Above: Polyurethane o-ring showing early signs of hydrolysis.

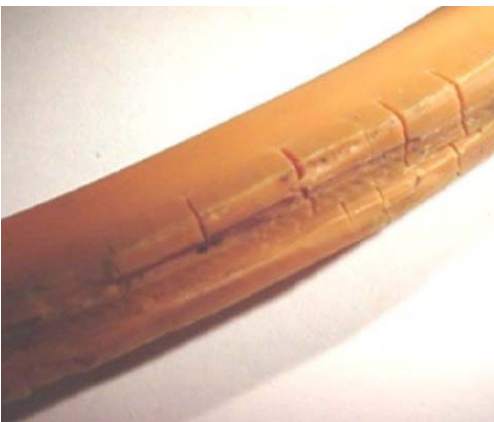
Above: Thermoplastic elastomer seal in the late stages of hydrolysis.

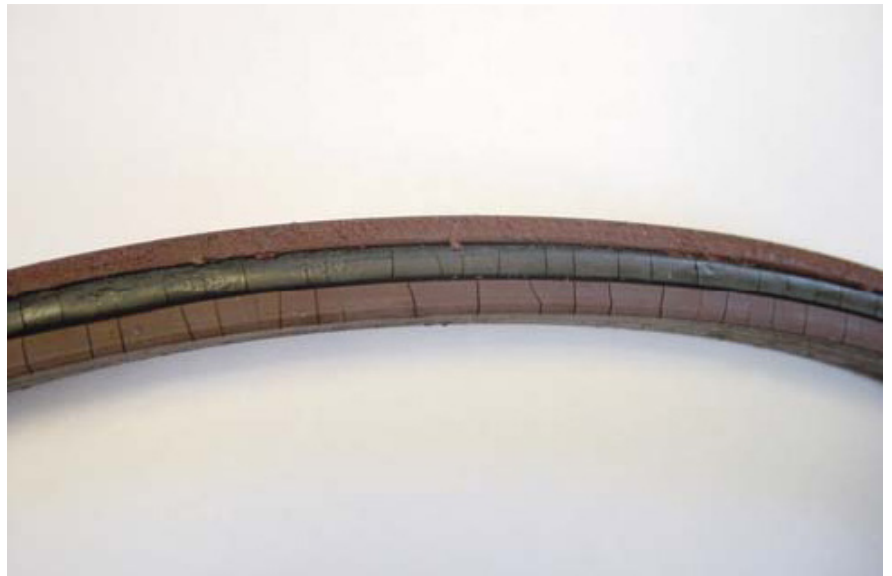
Above: Fluorocarbon (FPM) seal showing early signs of hydrolysis.

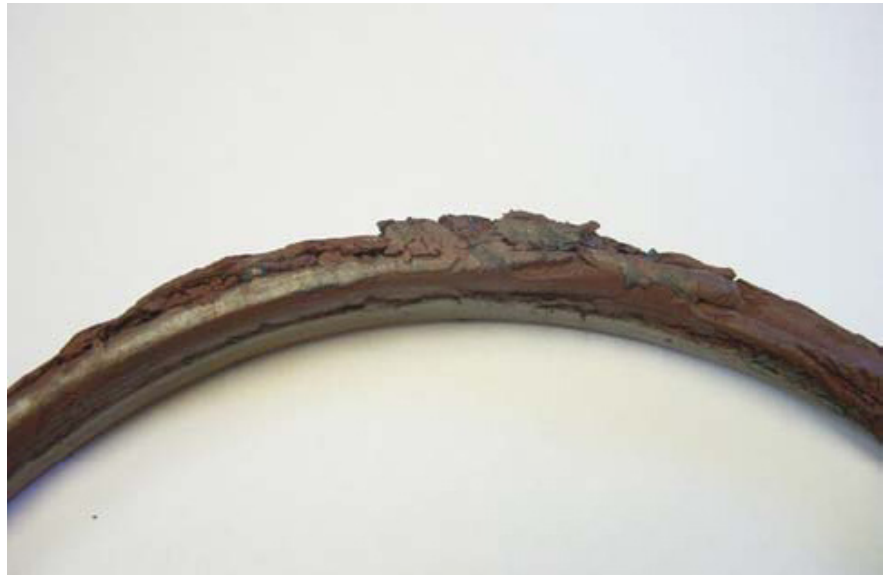
Above: Fluorocarbon (FPM) seal showing late stages of hydrolysis.

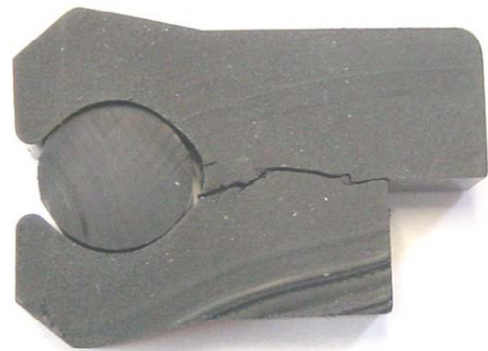
Above: Profile section of an o-ring loaded u-cup with flex fatigue cracking.

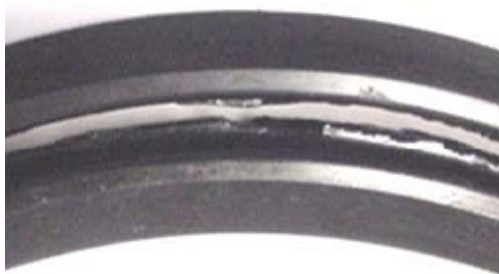
Above: Front view of a polyurethane seal with a flex fatigue crack through the middle section of the seal.

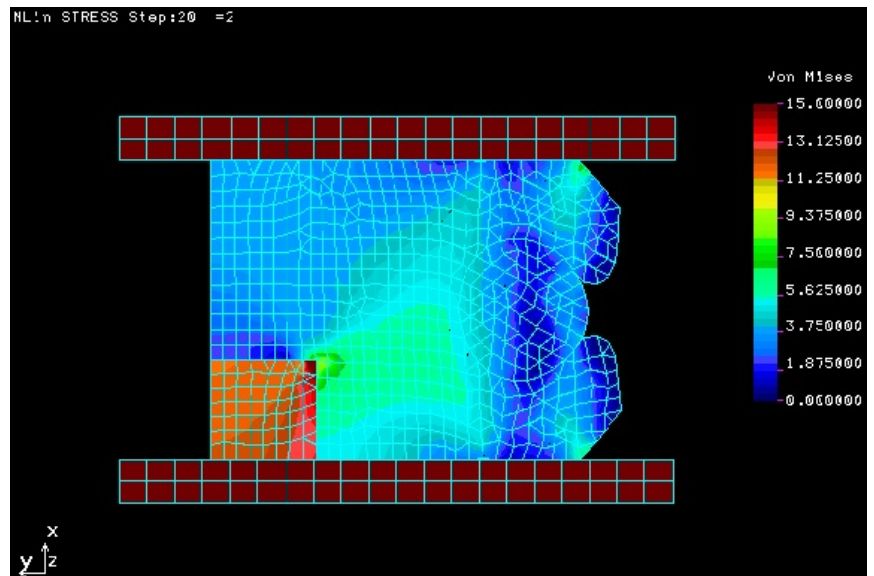
Above: Opposing tensile stresses flex the seal material during each pressure cycle, fatiguing the material over time. The stresses fatigue the material to the breaking point.

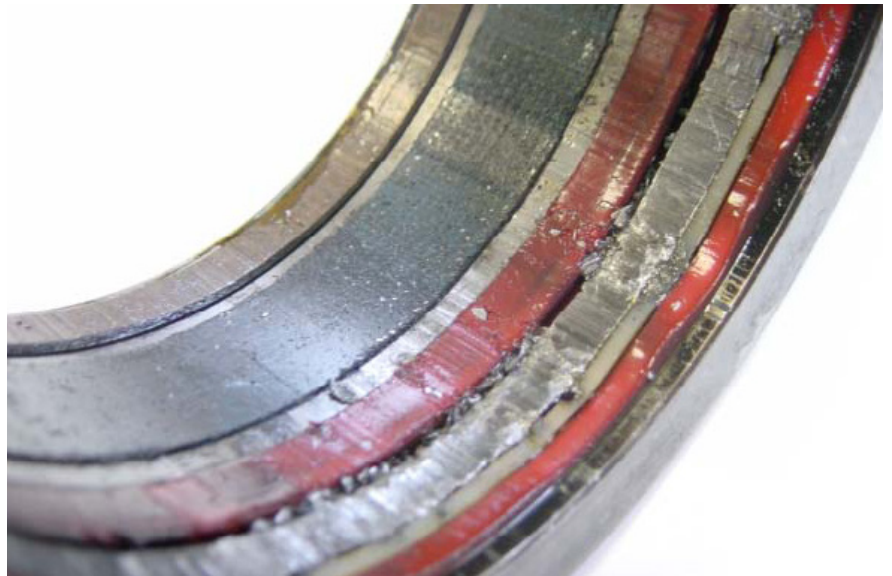
Above: Severe side loading with catastrophic damage from metal-to-metal contact.

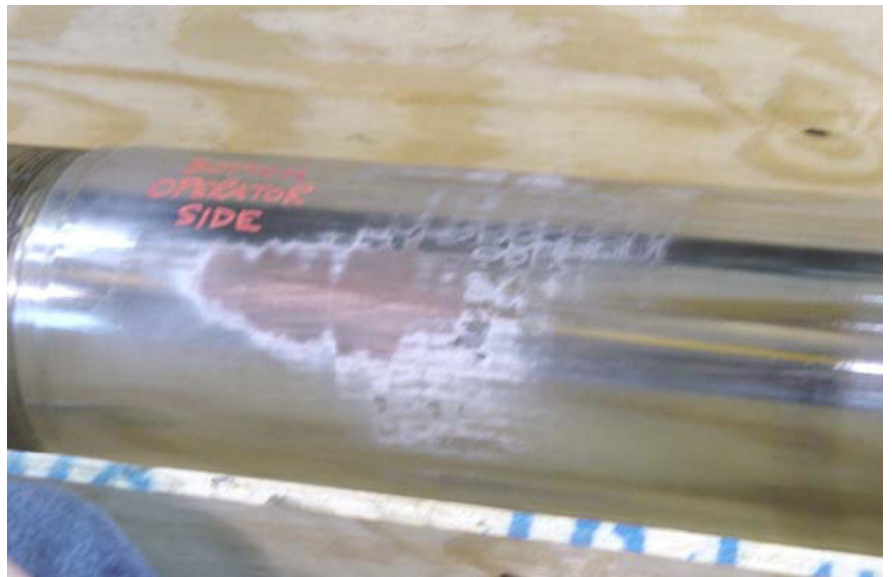
Above: Side loading that wore the chrome off the rod.

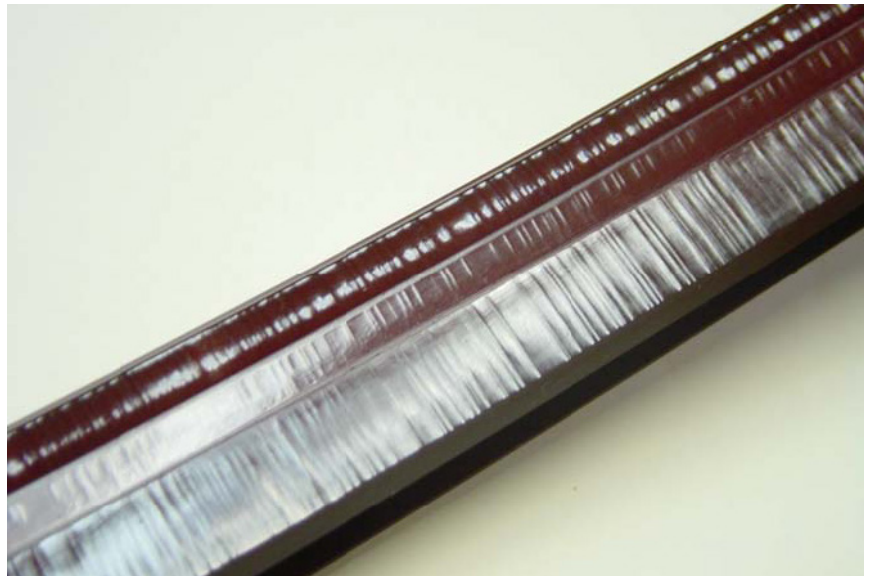
Above: Severe flow erosion of a polyurethane rod seal. Note the erosion starts at the seal lip (bottom) and migrates all the way across the seal.

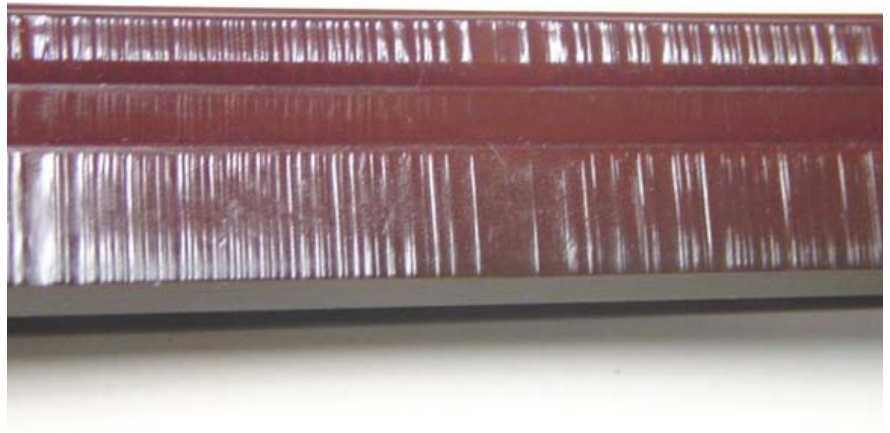
Above: Another view of the above polyurethane rod seal. Main seal lip is at the bottom.

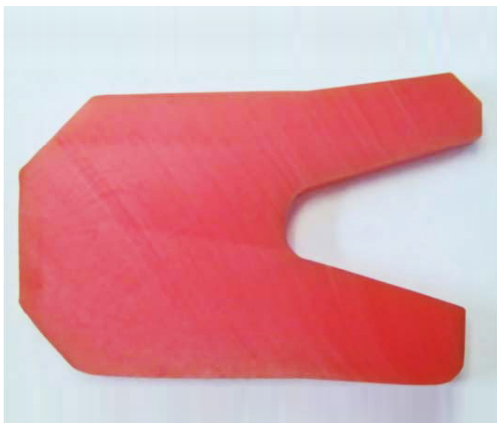
Above: Section profile of the above seal showing wear and loss of pre-load. Note the dynamic lip (bottom lip) has lost its sharp edge and has flattened compared to the top lip.

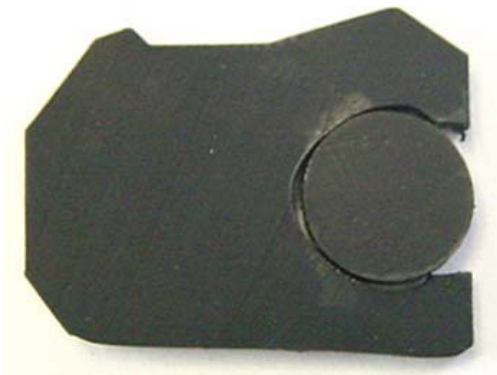
Above: Section profile of the above seal showing wear and loss of pre-load. Note both dynamic lips (bottom lips) have lost their sharp edges and have flattened compared to the top lips.

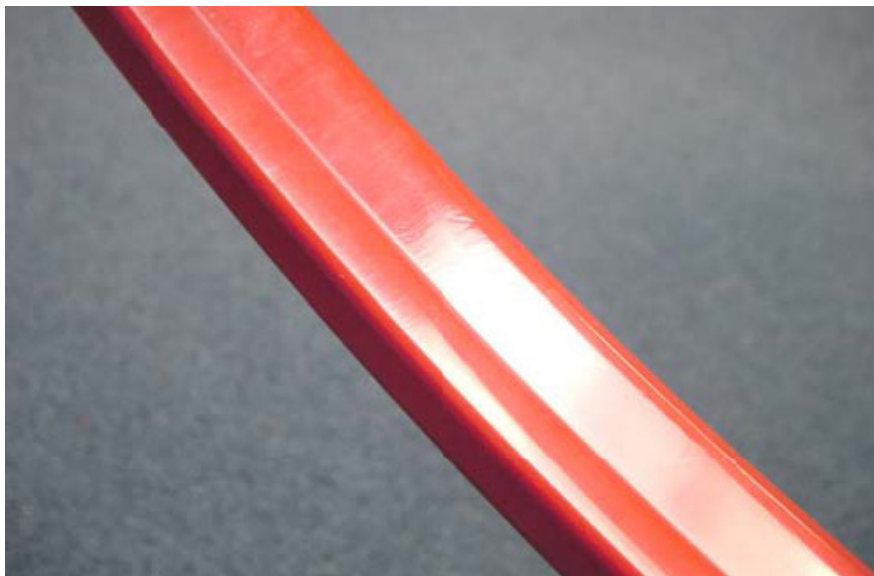
Above: Polyurethane rod seal with shiny and smooth surface from a dry running condition.

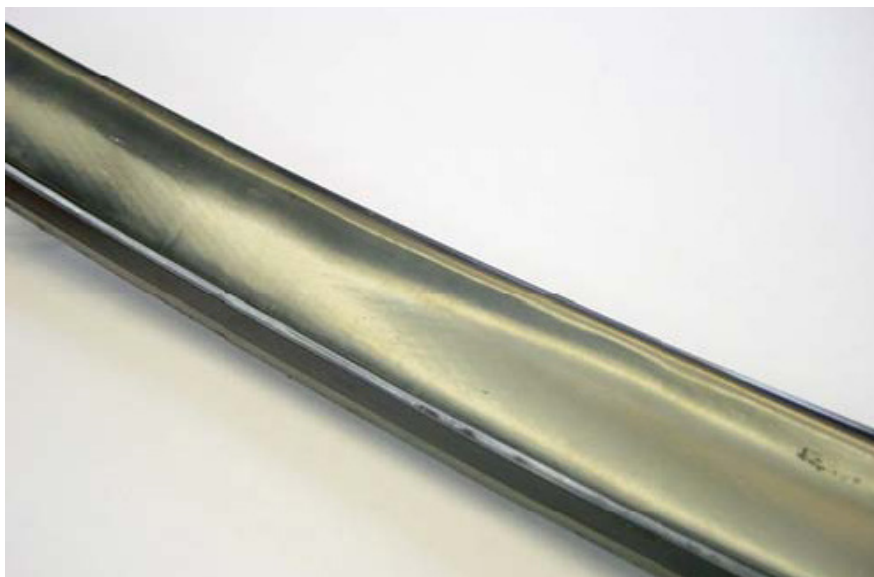
Above: NBR rod seal with shiny and smooth surface from low lubrication (water-based fluid).

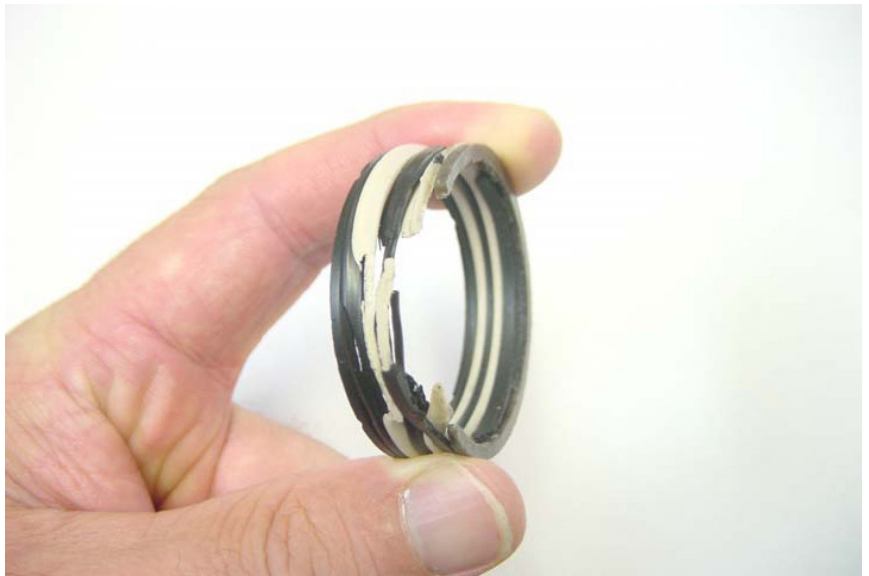
Above: V-packing set that structurally failed at 115,000psi.

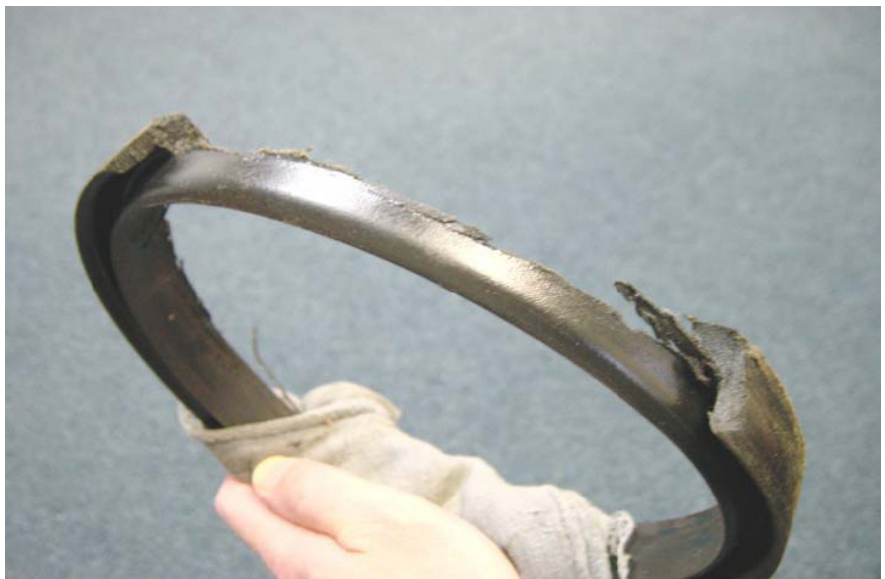
Above: Rubber and fabric piston seal that failed from over-pressurization
